NTSB National Transportation Safety Board

Office of Aviation Safety

Flight Crew Performance: Operational Factors

Captain David Tew Operations Group Chairman

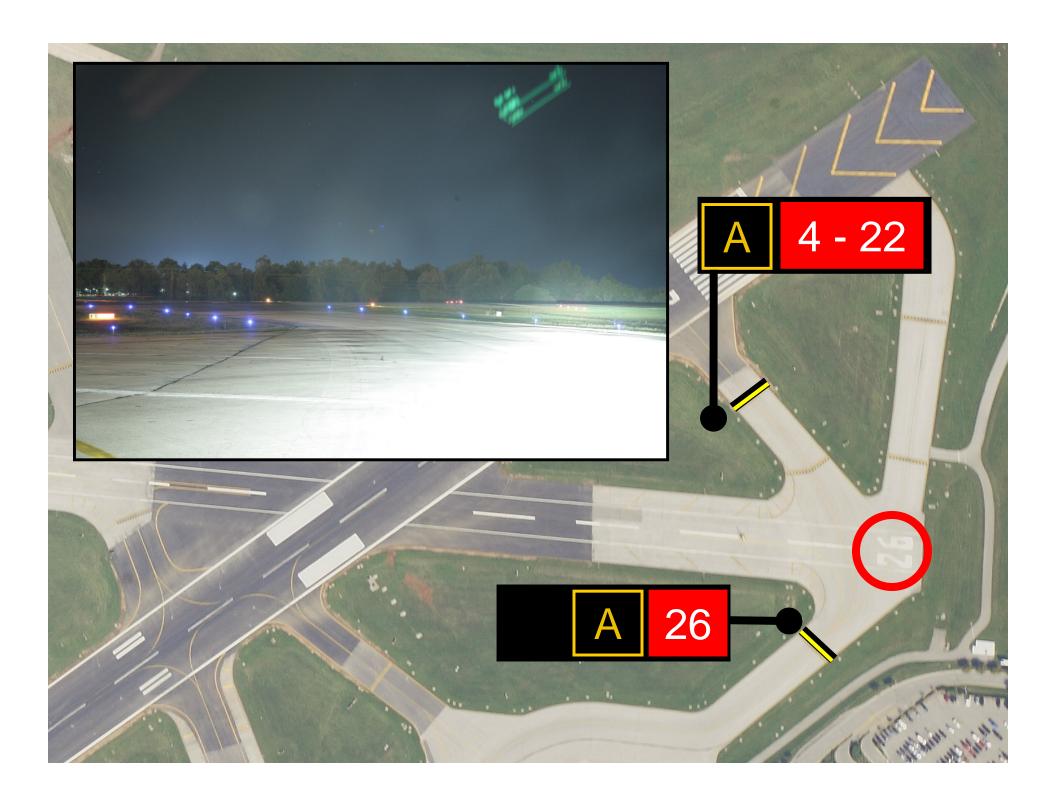
- Stopped at runway 26 hold short line
- Advised controller that flight ready to depart
- Time was available for flight crew to confirm airplane's location
